# Stress Analysis of a Tuner for an Electromagnetic Reverberation Chamber

DSTO-TN-0272

Air Operations Division Aeronautical and Maritime Research Laboratory

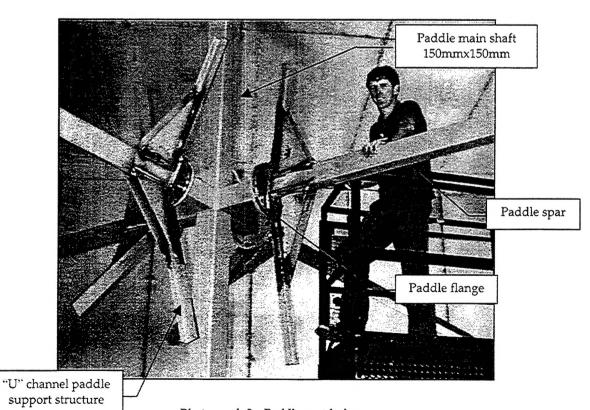
Photograph 3 Paddle root hub area

The stress in the weld between the hub root and the main shaft was found to be quite high in this case. The stress was calculated to be 411.9MPa, giving a safety factor of 1.1.

Due to the low safety margin, it is recommended that four load distribution webs be installed to redistribute the load from one paddle to all four paddles. This will reduce the stress in the weld by a factor of 4, giving a new safety factor of 4.4. Details of the recommended webs are shown at figure A-6 in Appendix A, and illustrated by sketches SPA060, and SPA061 in Appendix B.
